RESEARCH MEMORANDUM

FLYING QUALITIES OF A HIGH-PERFORMANCE

PERSONAL-OWNER AIRPLANE

By James J. Adams and James B. Whitten

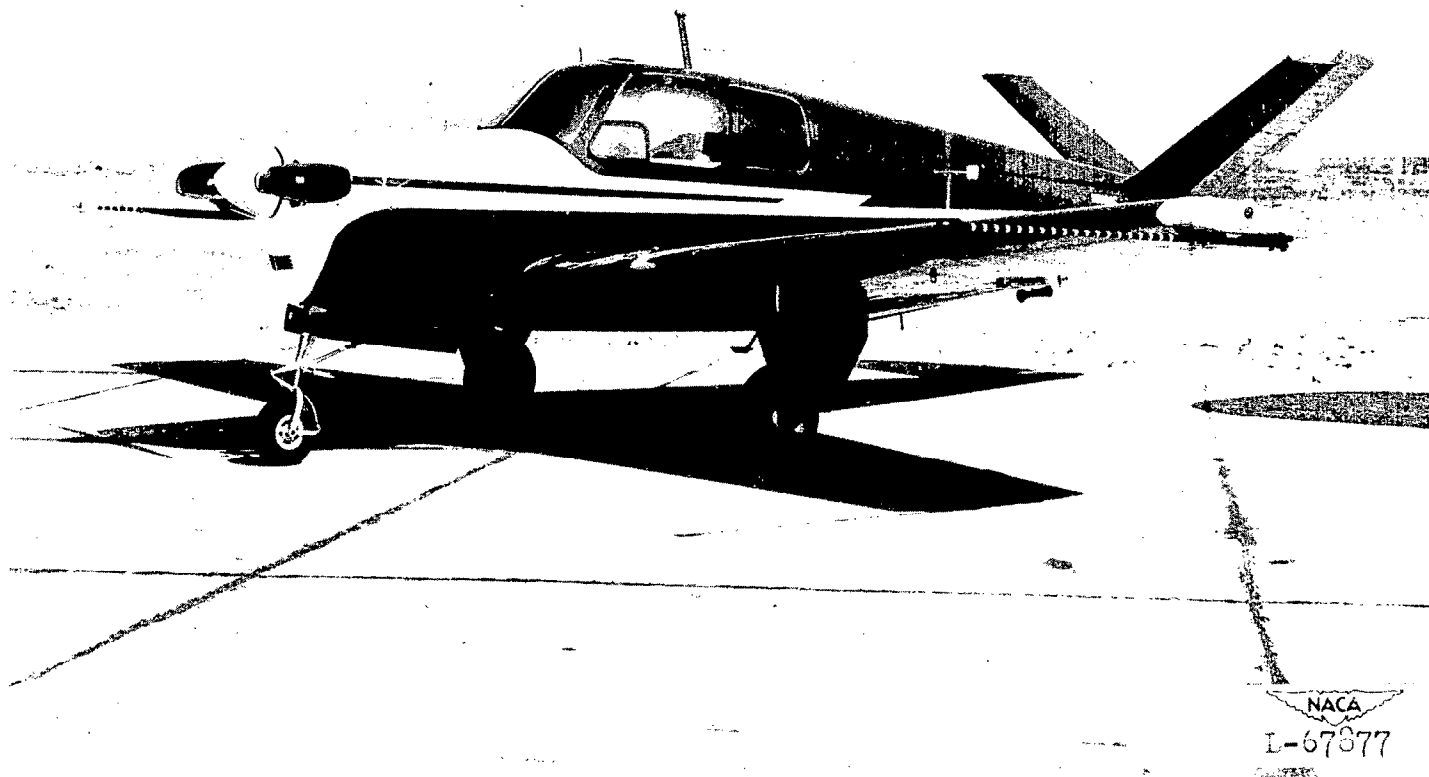
(a) Three-quarter front view.

Figure 1.- Beech B-35 Bonanza airplane.

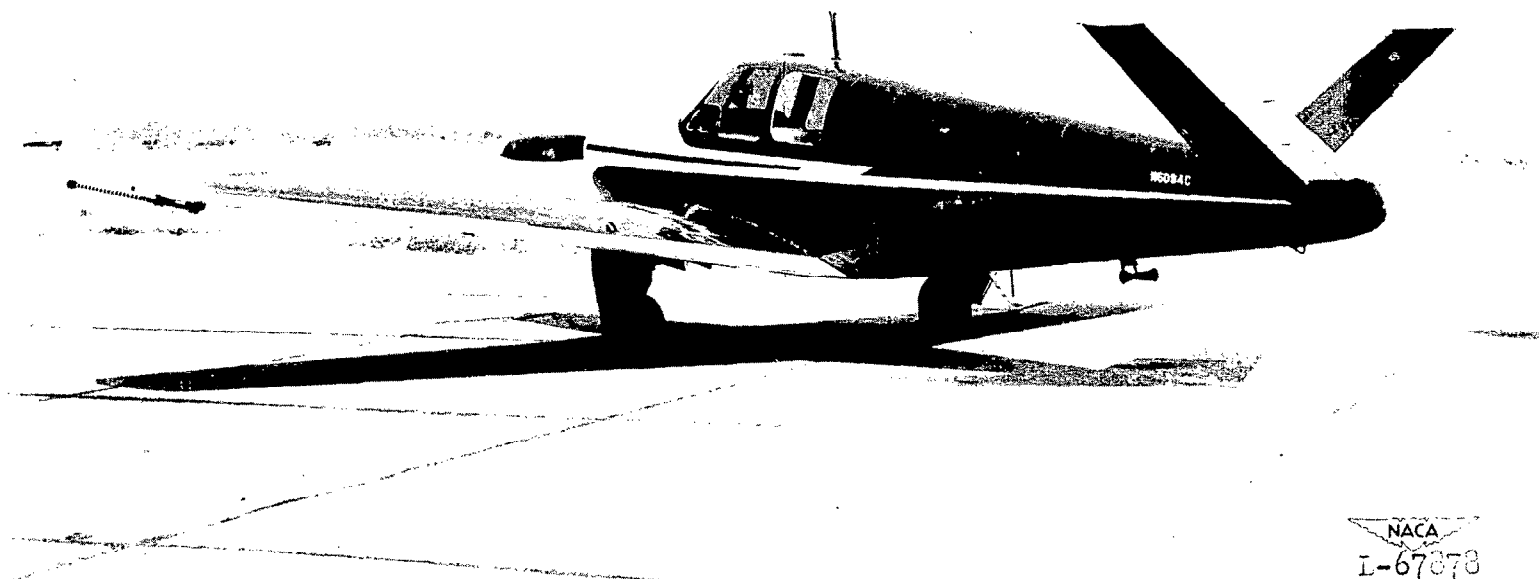
(b) Three-quarter rear view.

Figure 1.- Concluded.

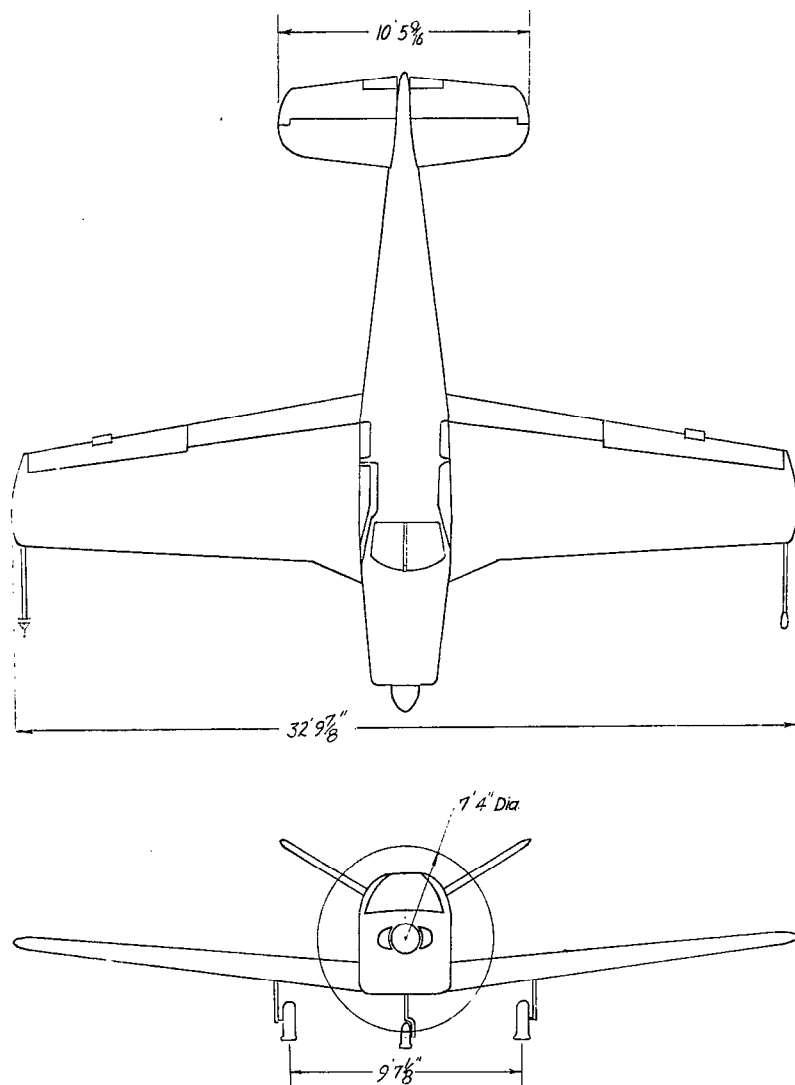
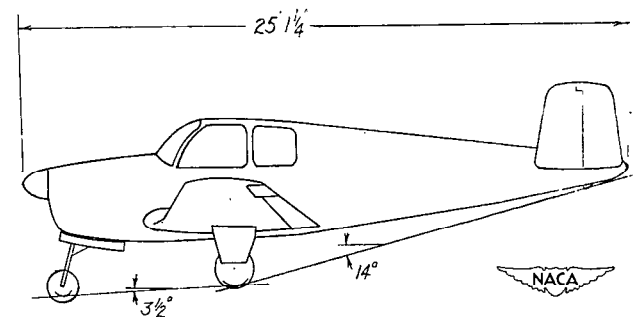
Figure 2.- Three-view drawing of the Beech B-35 Bonanza airplane.

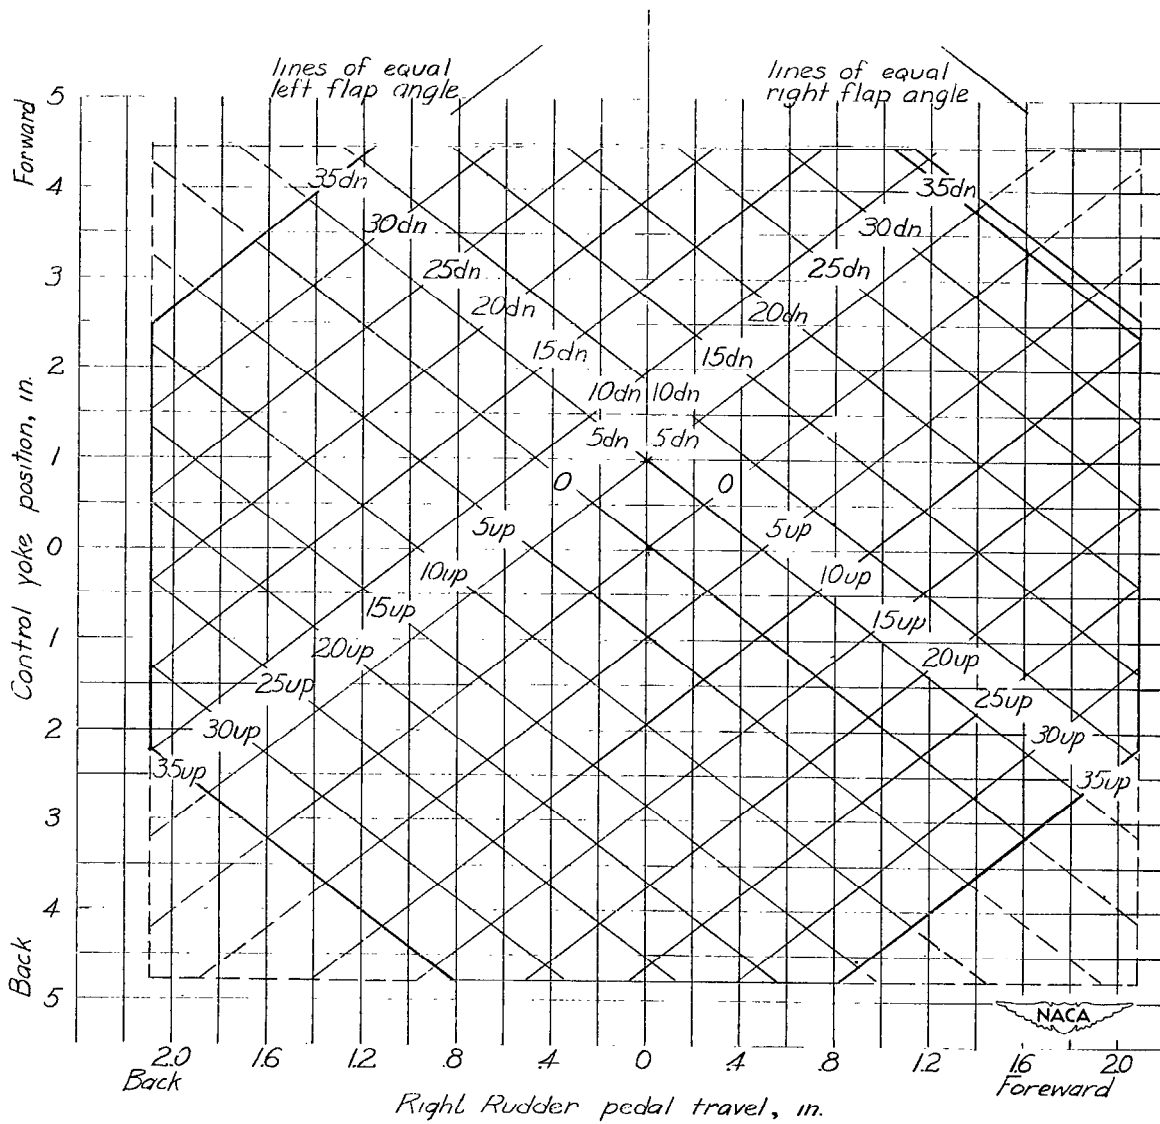
(a) Elevator-rudder control.

Figure 3.- Variation of control flap position with pilot's control position for the Beech B-35 Bonanza airplane.

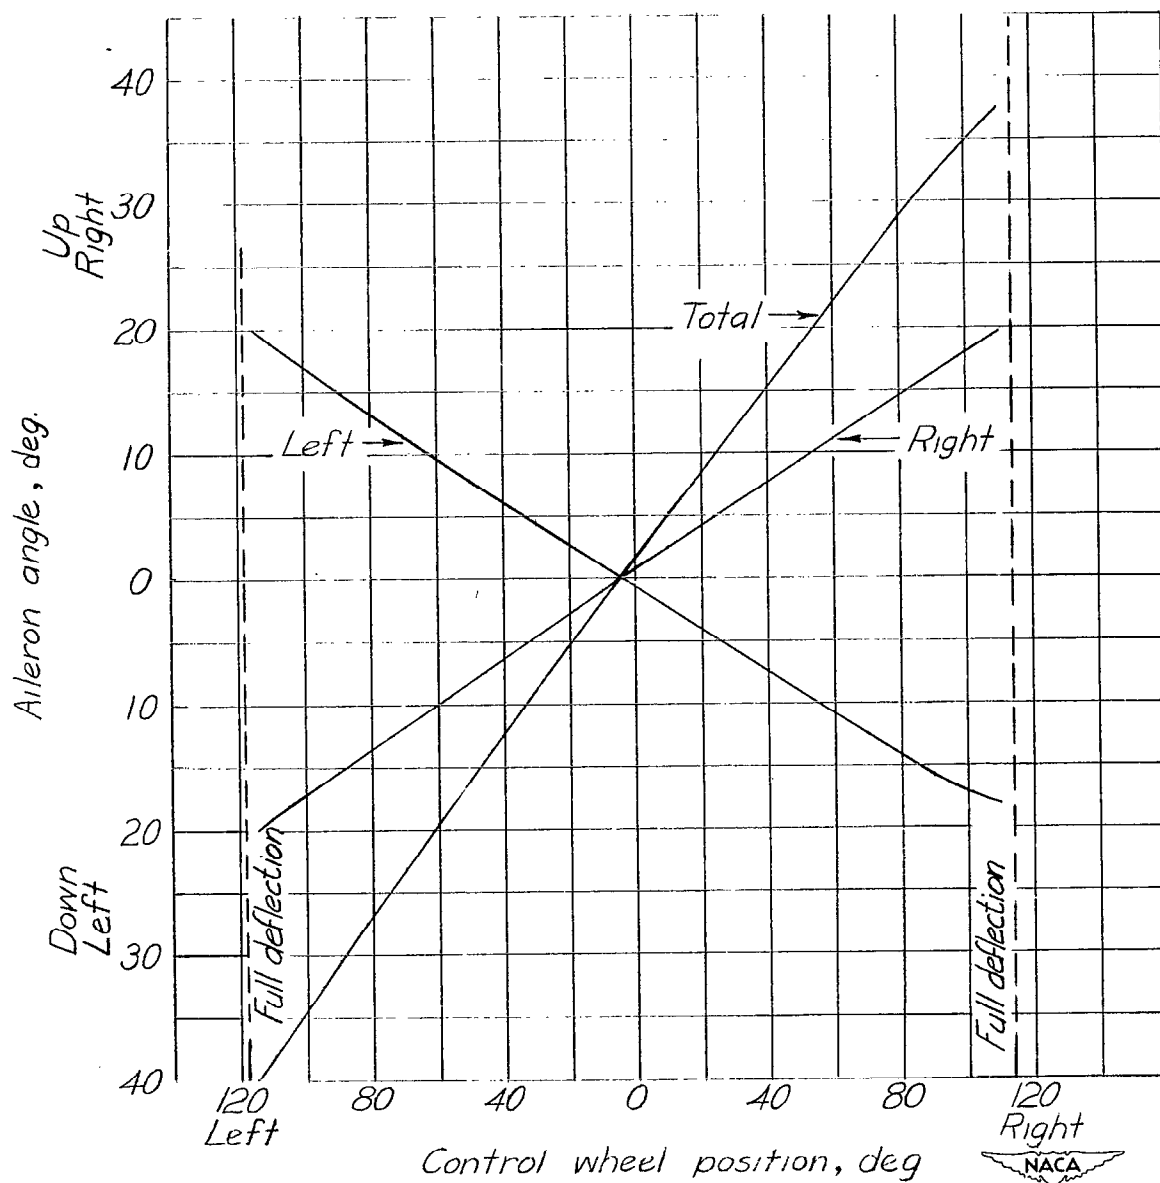
(b) Aileron control.

Figure 3.- Concluded.

A plot of the variation of aileron angle with control-wheel angle is shown in figure 3(b).

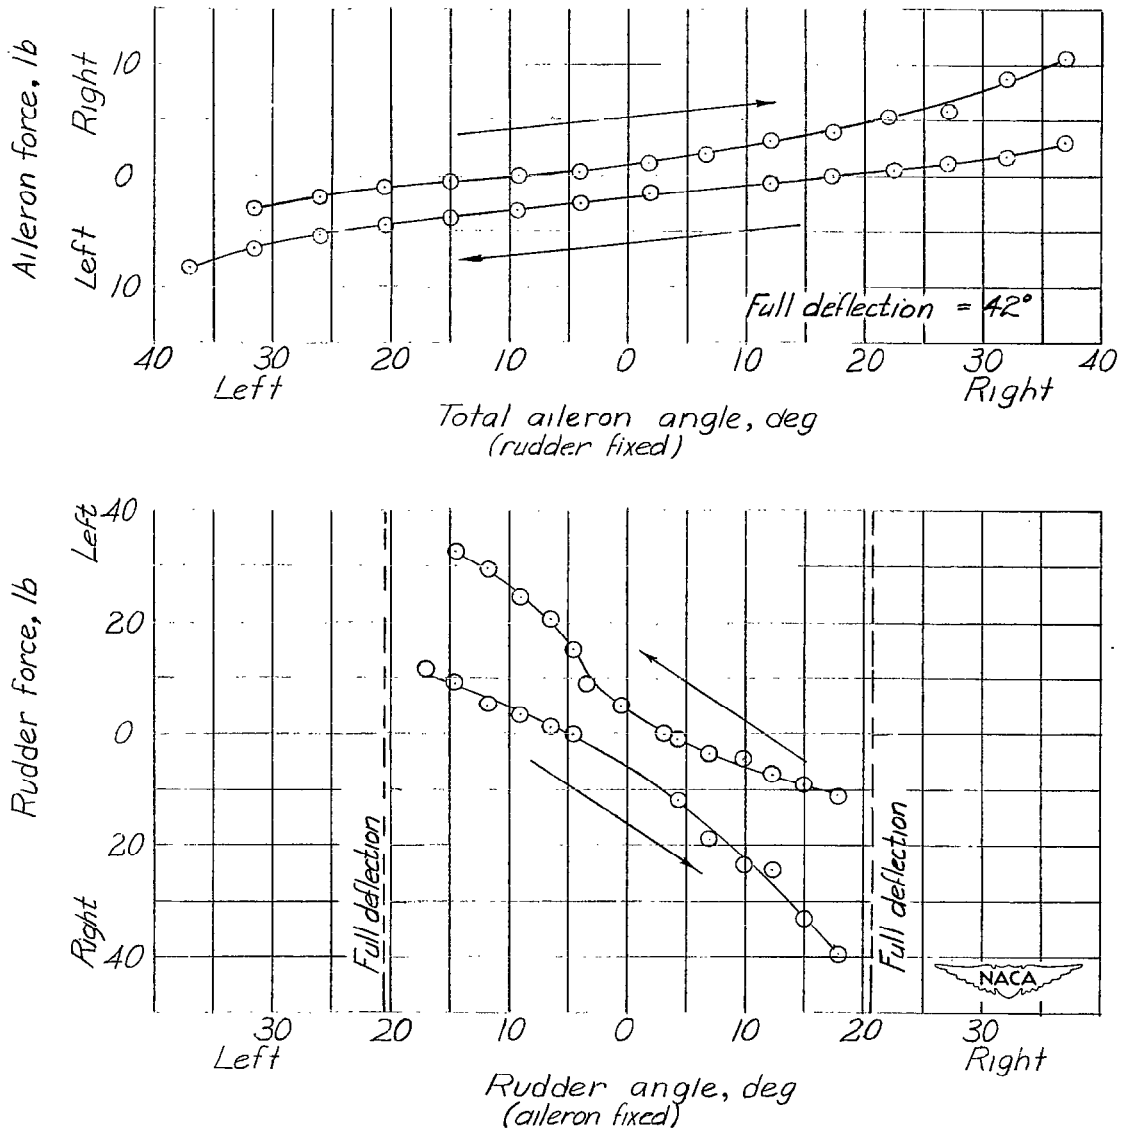
(a) Aileron and rudder control.

Figure 4.- Variation of control force with flap position showing the control system friction and spring forces for the Beech B-35 Bonanza airplane.

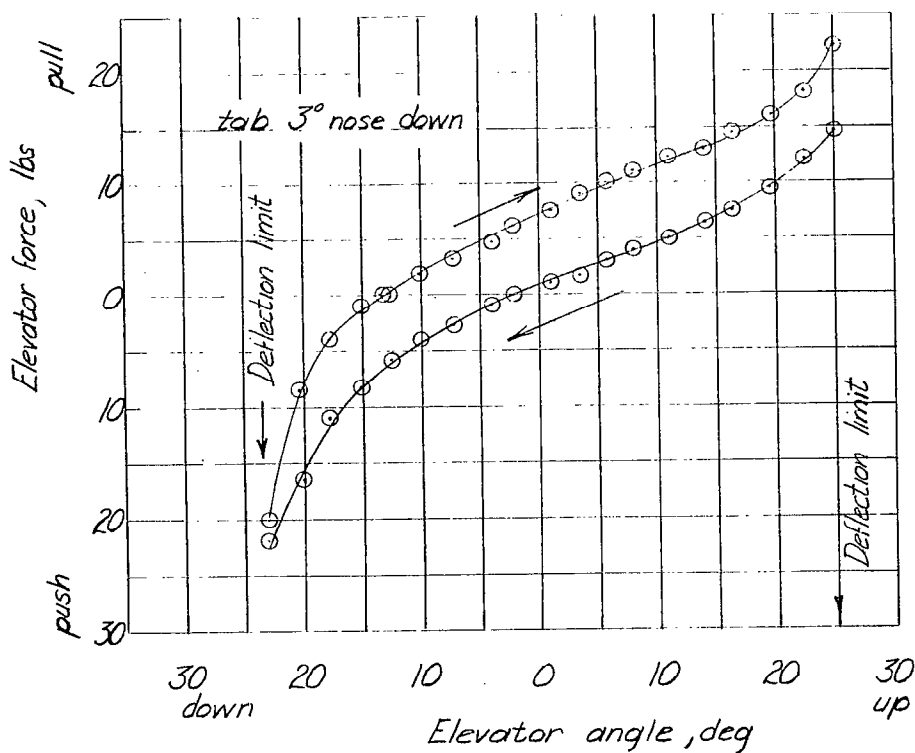
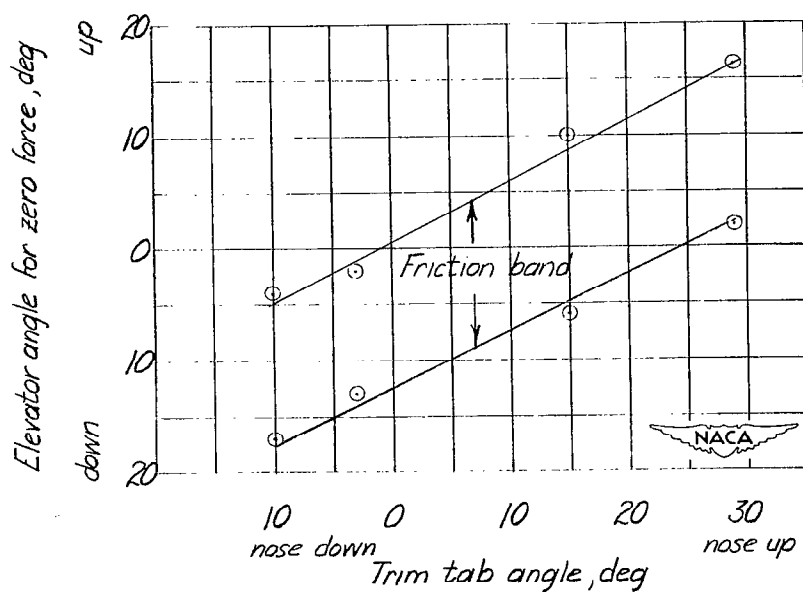
(b) Elevator control.

Figure 4.- Concluded.

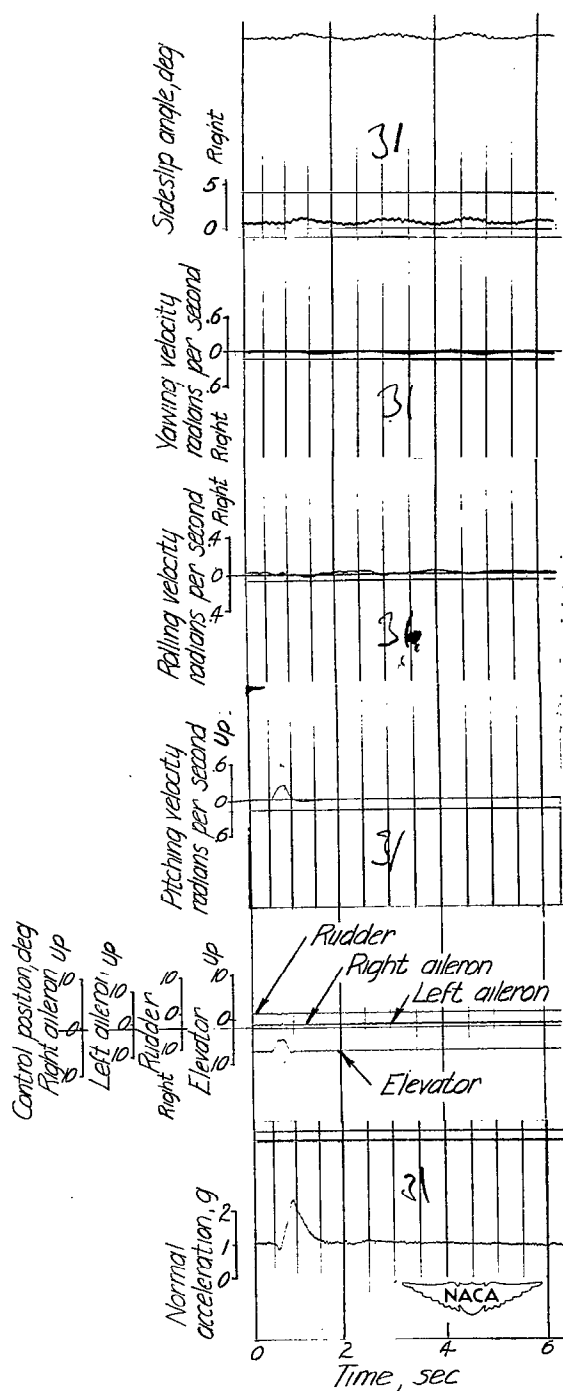
Figure 5.- Time history of the control free oscillations following an abrupt movement and release of the elevator. Airplane in the power on, clean condition; airspeed = 180 miles per hour. Center of gravity located at 26.1 percent mean aerodynamic chord; Beech B-35 Bonanza airplane.

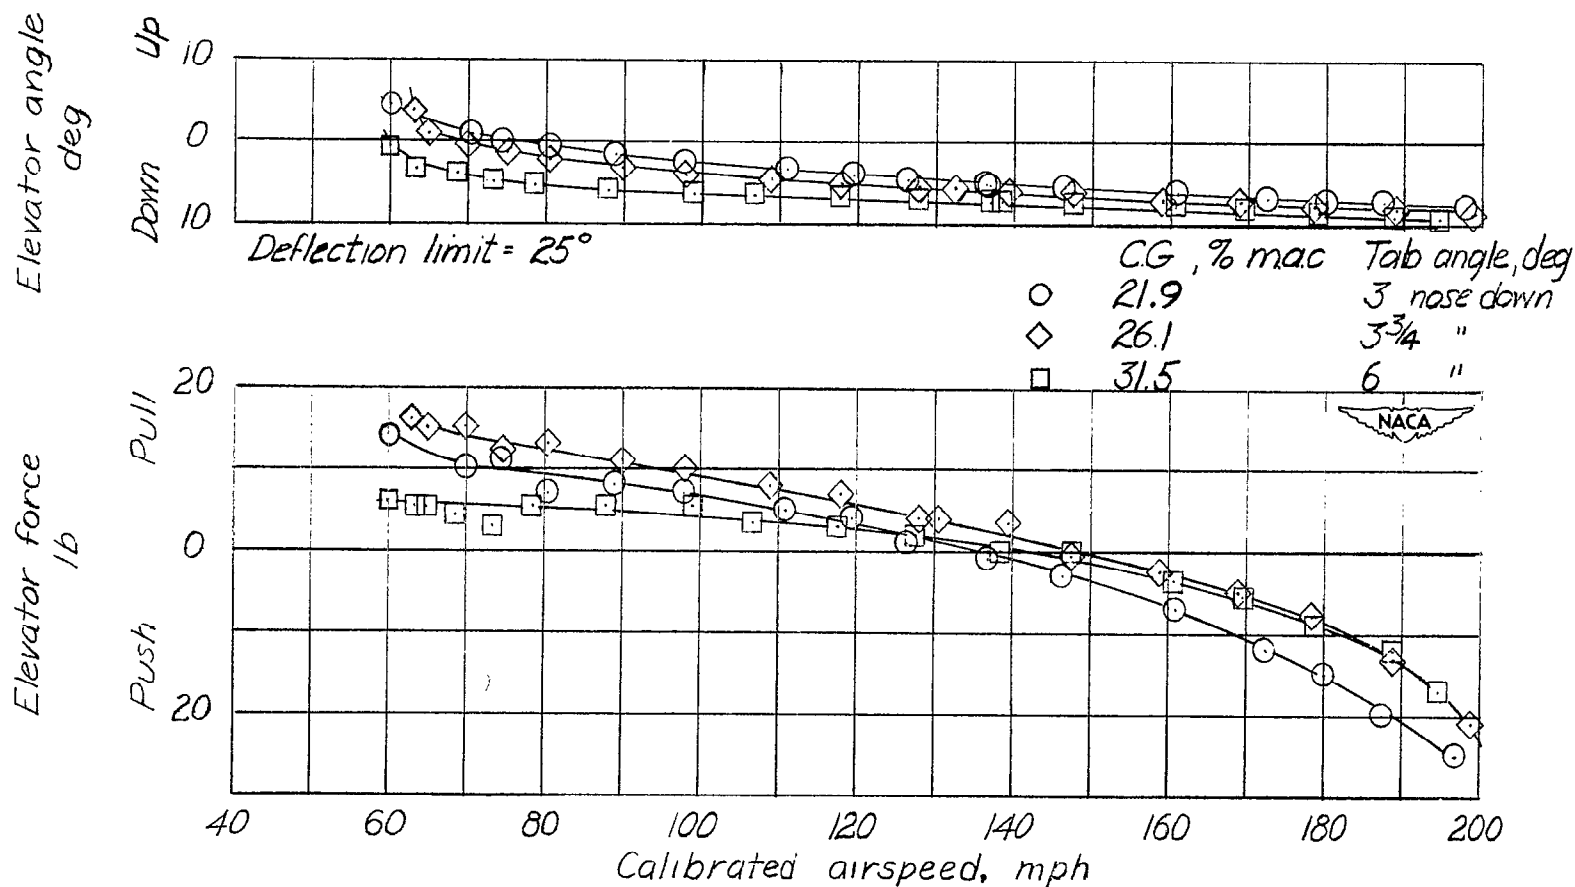
(a) Power on (cruising power, 22 in. Hg at 2050 rpm); clean condition.

Figure 6.- Static longitudinal stability characteristics of the Beech B-35 Bonanza airplane.

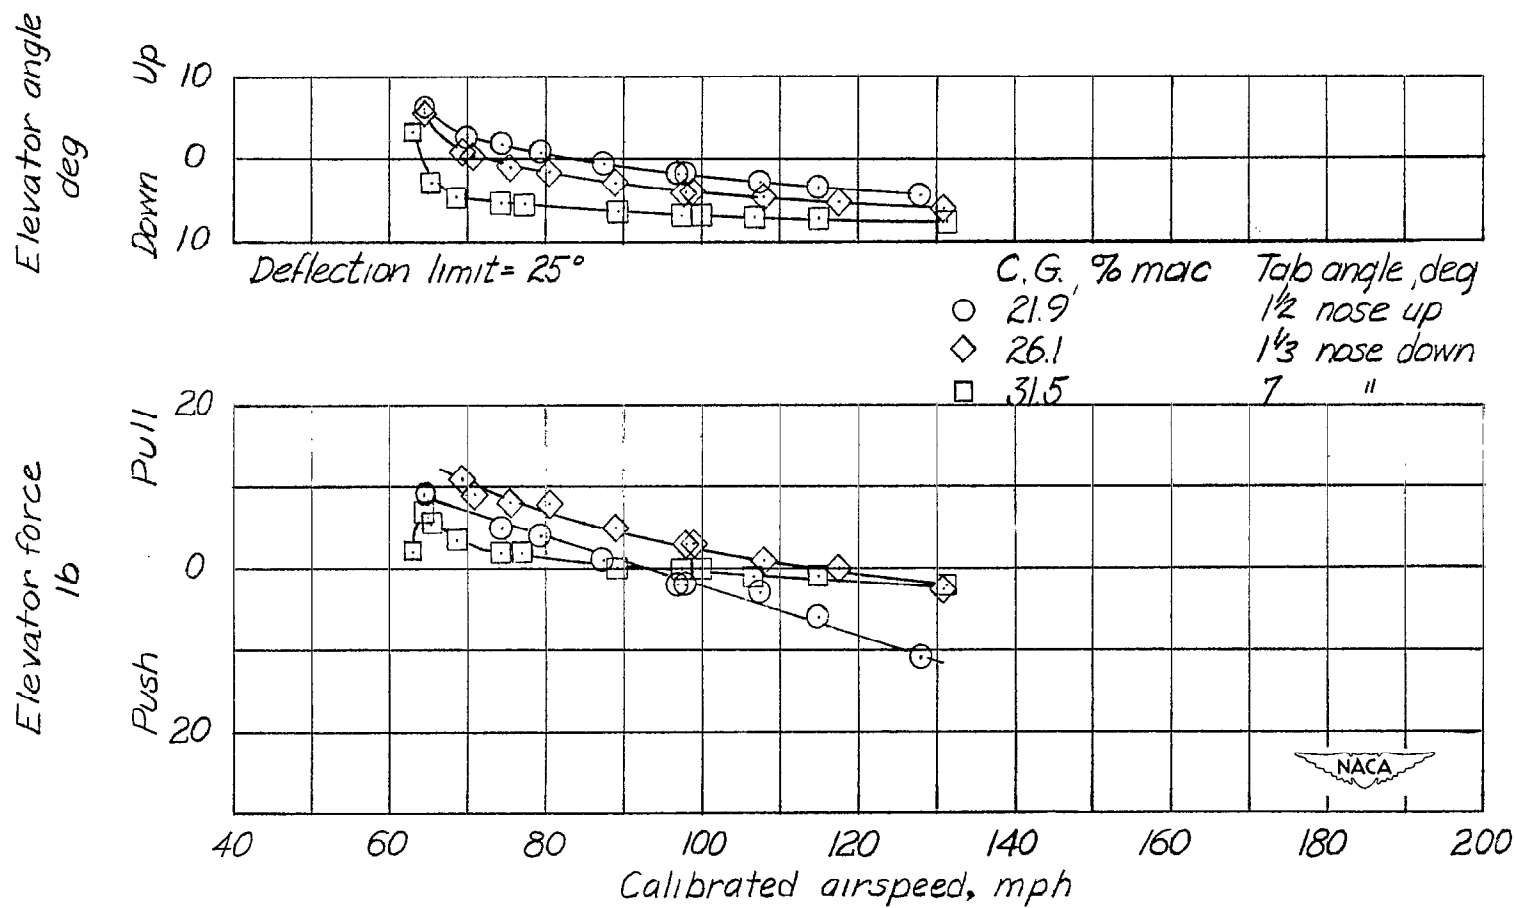
(b) Power off; clean condition.

Figure 6.- Continued.

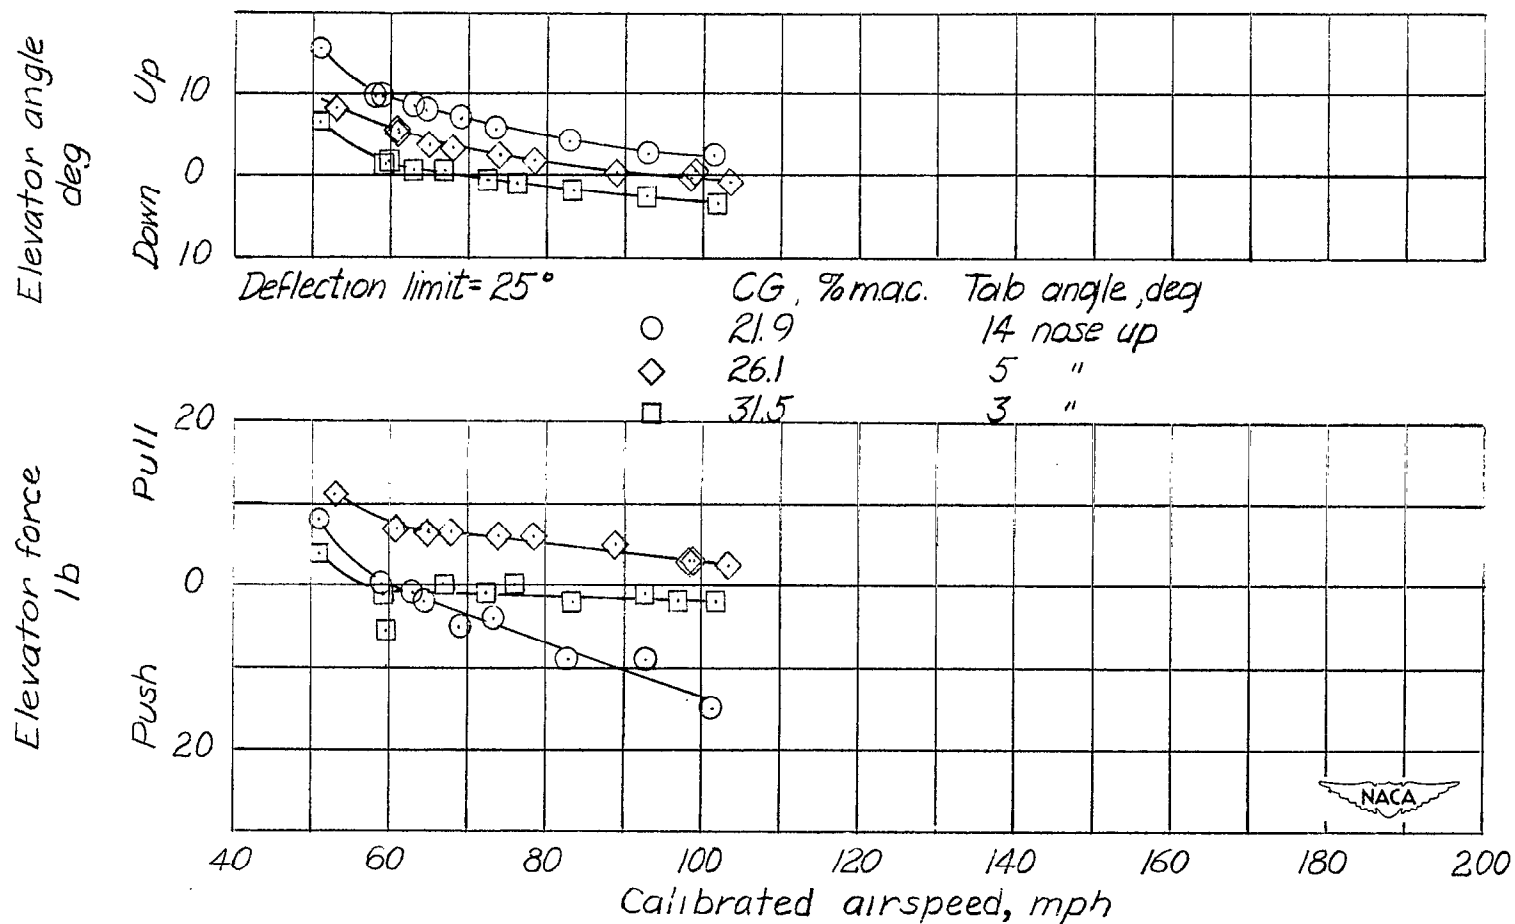
(c) Power on (22 in. Hg at 2050 rpm); flaps and gear down.

Figure 6.- Continued.

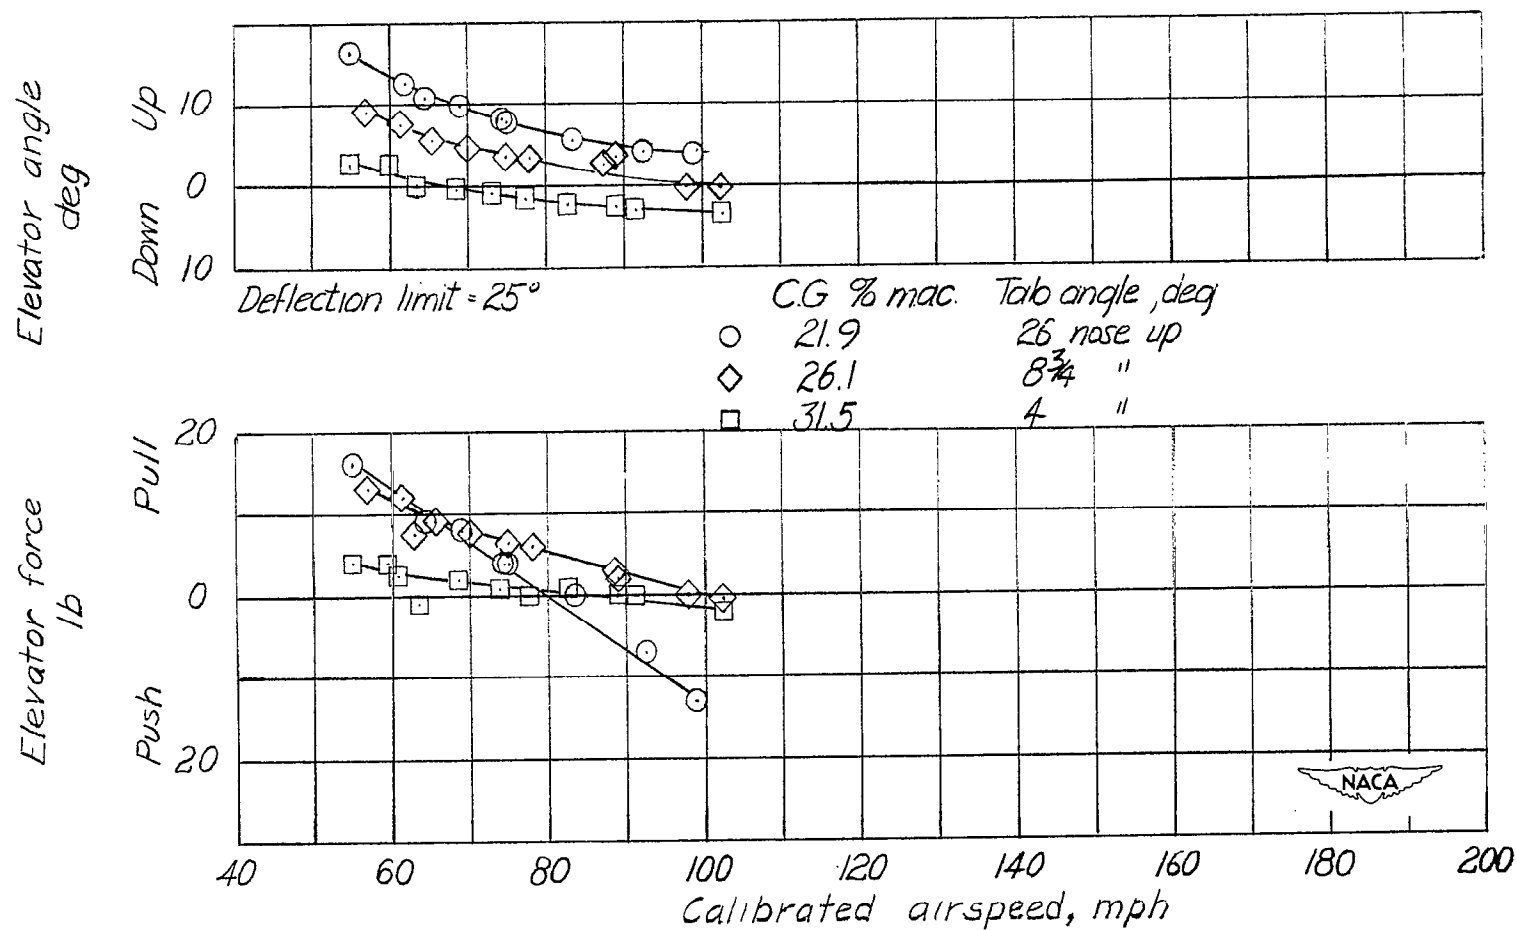
(d) Power off; flaps and gear down.

Figure 6.- Concluded.

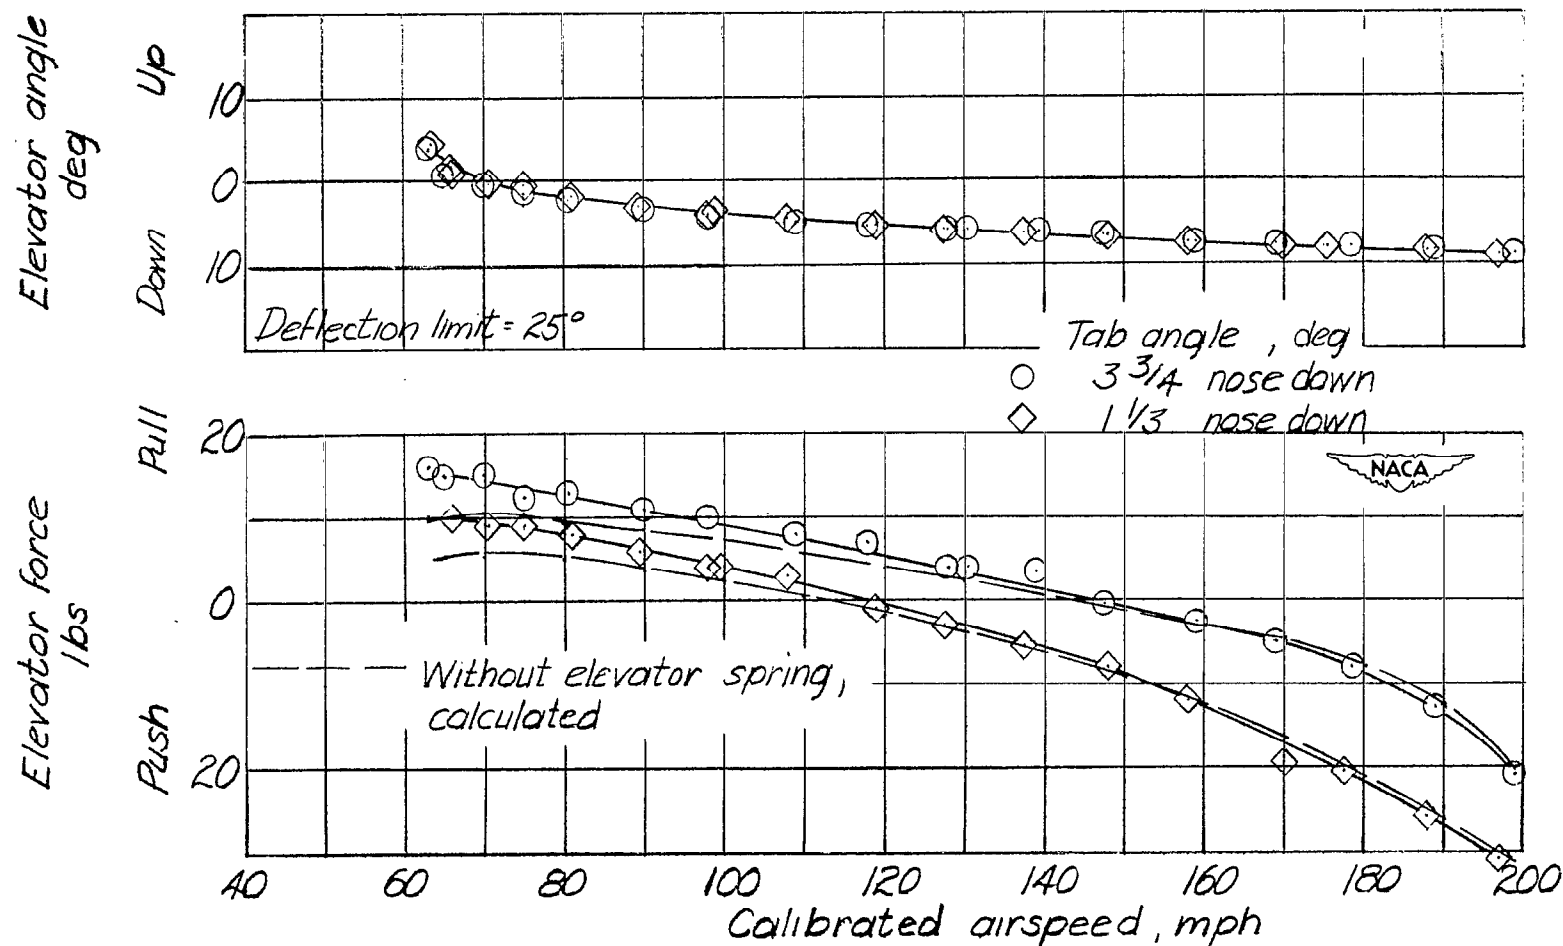
Figure 7.- Variation of elevator position and force with airspeed for two different trim tab settings for the Beech B-35 Bonanza airplane in power on (cruising power, 22 in. Hg at 2050 rpm); clean condition.

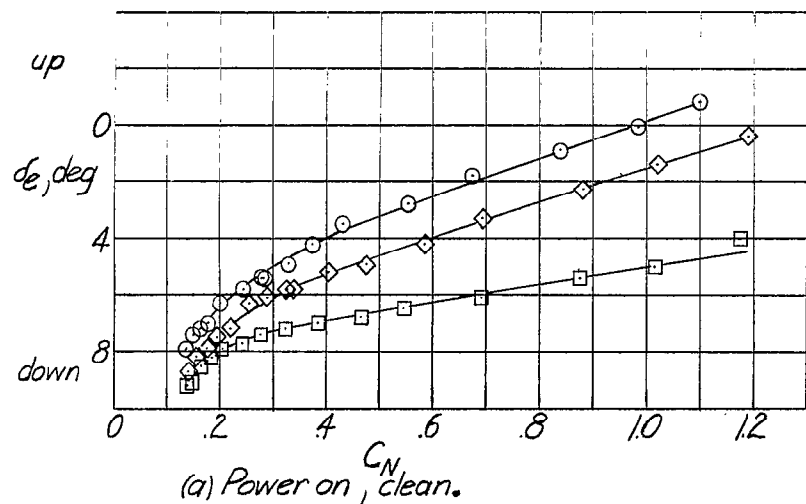
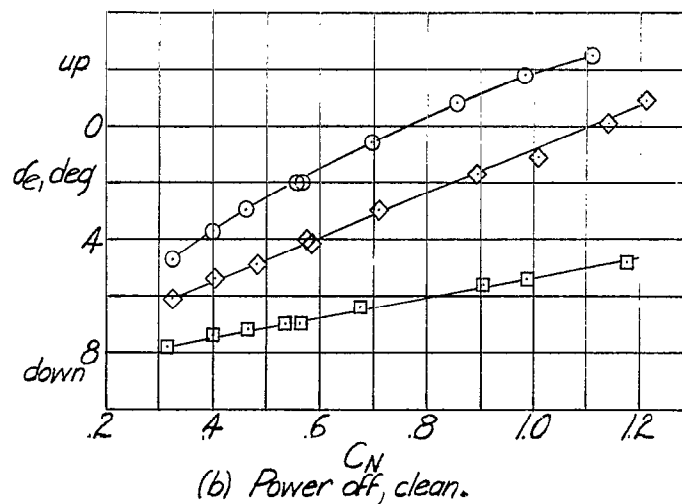
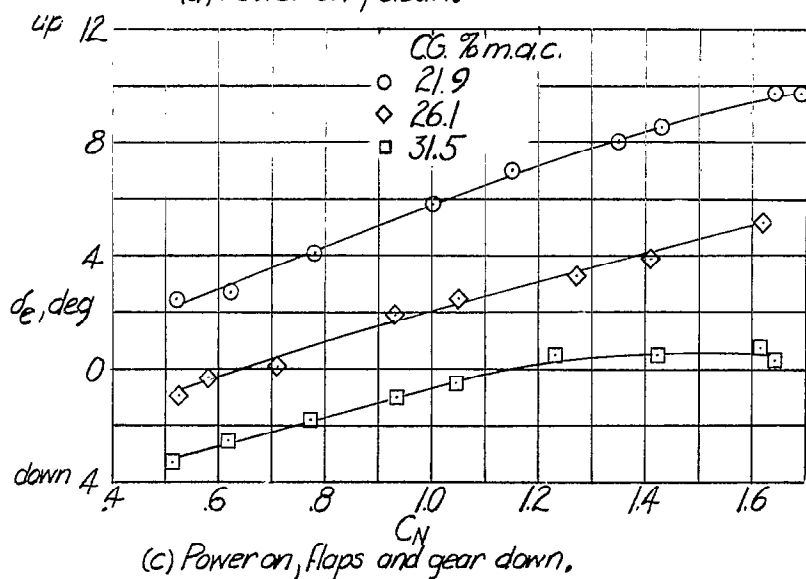
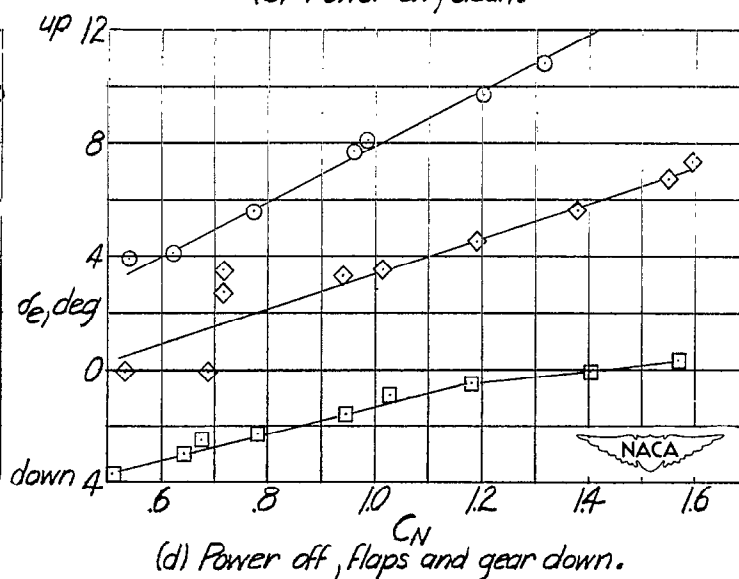
Figure 8.- Variation of elevator angle with normal-force coefficient at various centers of gravity.

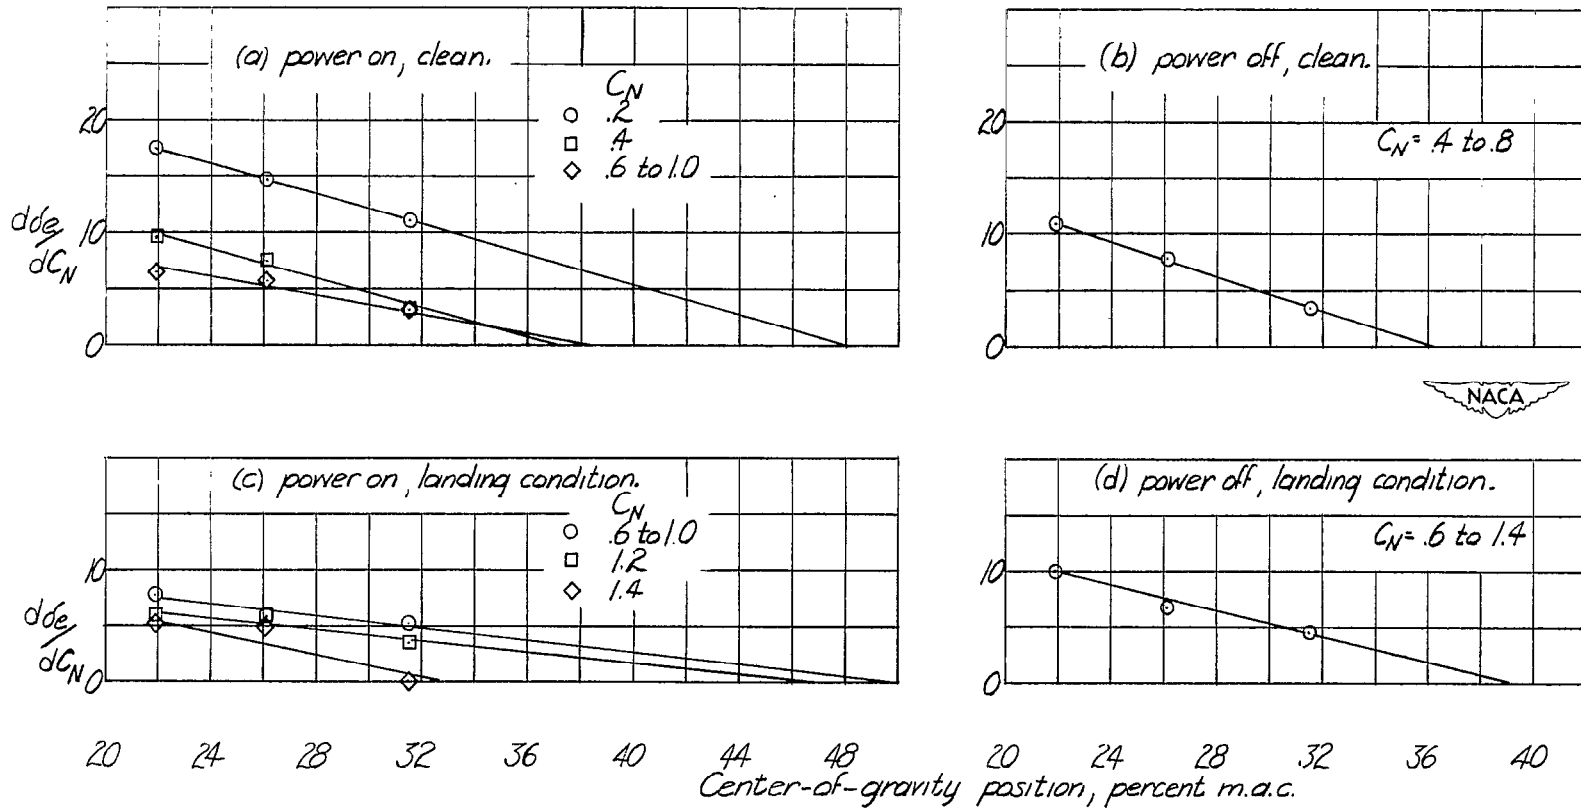
Figure 9.- Stick-fixed neutral points of the Beech B-35 Bonanza airplane.

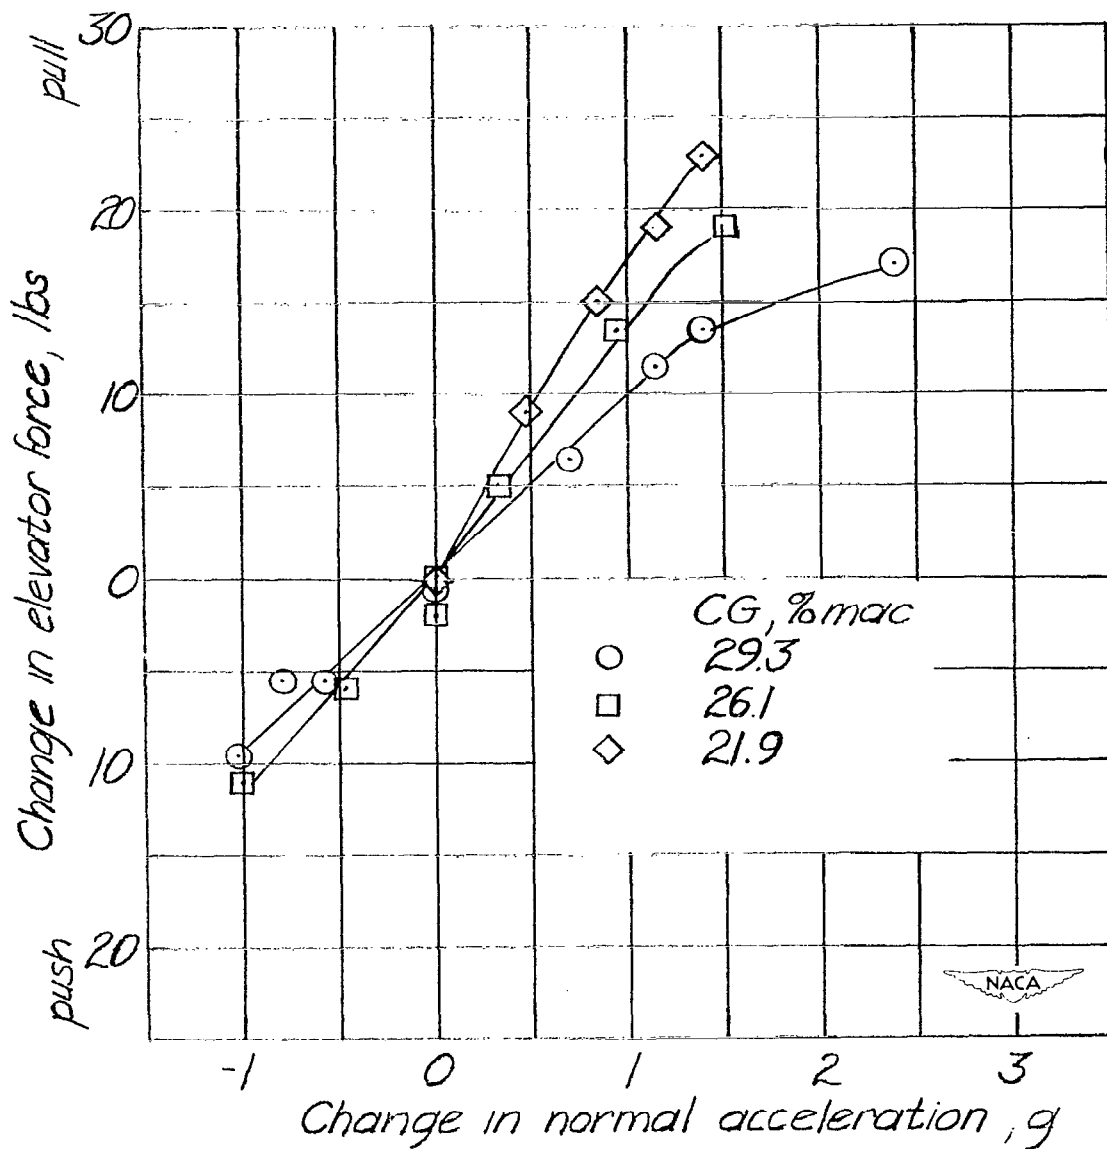
(a) In steady pull-up and push-down maneuvers.

Figure 10.- Variation of elevator force with normal acceleration for three different center-of-gravity positions in the power-on clean condition at approximately 130 miles per hour for the Beech B-35 Bonanza airplane.

Longitudinal control.- The longitudinal control characteristics were measured by performing steady pull-ups, push-downs, and turns at various speeds and center-of-gravity locations and measuring the elevator control force. Plots of the elevator control force against g are shown in figures 10 and 11. From figure 10 it can be seen that the variation of elevator force with g is linear, falling off only when the airplane approaches the stall. The variation of force per g with center-of-gravity position obtained from figure 10 was extrapolated to give the force per g values at the most forward and rearward allowable center-of-gravity positions. The values of 21 pounds per g to 10 pounds per g determined in this manner were considered to be in a satisfactory range.

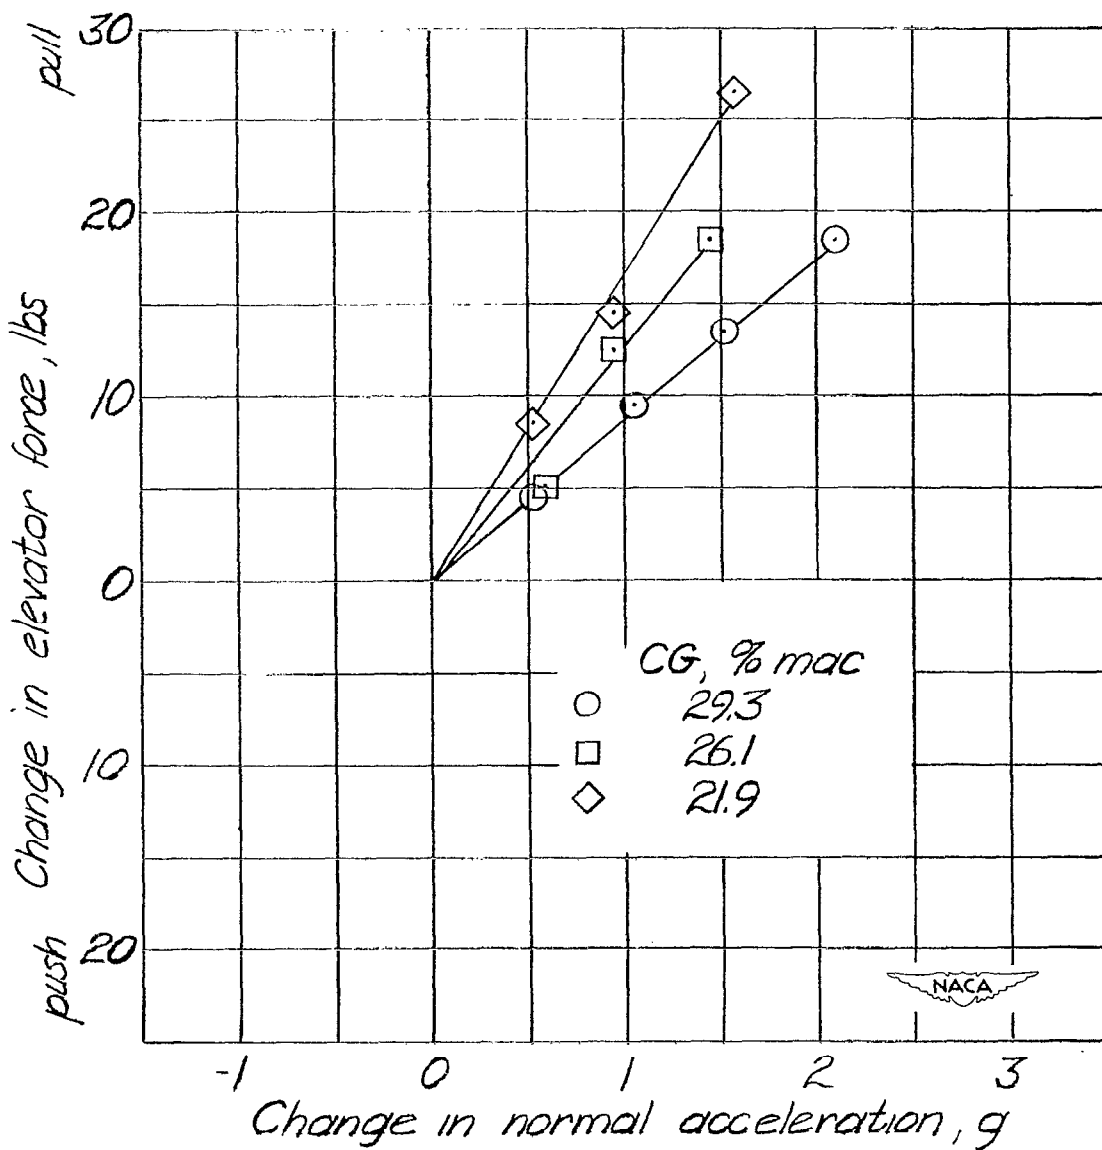
(b) In steady turns.

Figure 10.- Concluded.
